Manhole Inspection Summary

Manhole # S270__003MH

Insp Date: **4/30/08 1:13 PM**

Location Address: **Dexter St**

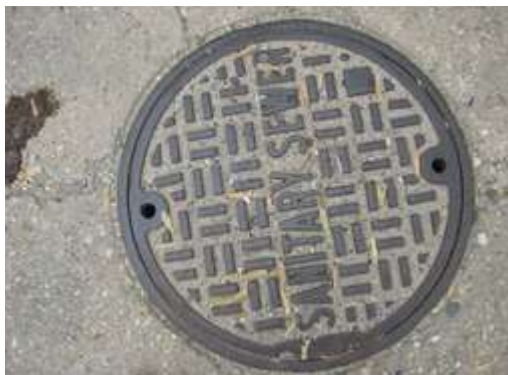
Cover View

Type: **Sanitary** Condition: **Sound** Cover Material: **Cast Iron**

Frame Offset: **1** (in.) Condition: ☐ Sound ☐ Cracked ☒ **Leaks**

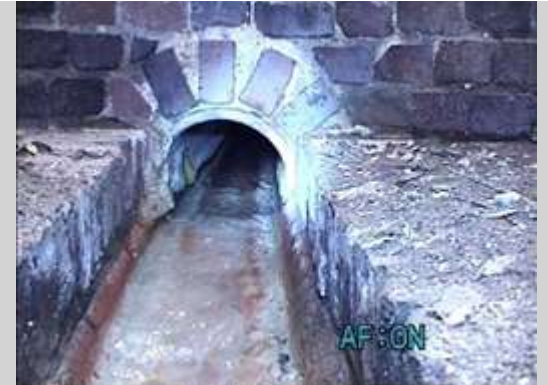
12 O'Clock Outflow

8 in. Circular Gravity Sewer
Pipe Out @ 12 O'Clock

Pipe Height: **8.4** (in.) Rod and Bar (Angled)
Pipe Material: **Clay** ☐ Pipe Lined
Invert Depth: **7.99** (ft.) Flow Characteristics: **Fast**
Deposits: ☒ None ☐ Mud ☐ Sludge ☐ Debris ☐ Grease
Silt Depth: **0** (in.) Deposits Extent:
Infiltration: **None** Pipe Seal Cond: **Sound**

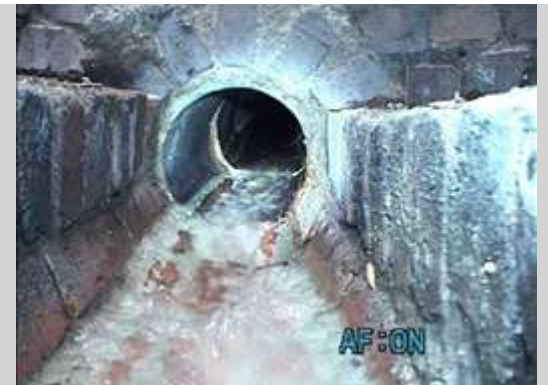
6 O'Clock Inflow

8 in. Circular Gravity Sewer
Pipe In @ 6 O'Clock

Pipe Height: **8.4** (in.) Rod and Bar (Angled)
Pipe Material: **Clay** ☐ Pipe Lined
Invert Depth: **8.01** (ft.) Flow Characteristics: **Fast**
Deposits: ☒ None ☐ Mud ☐ Sludge ☐ Debris ☐ Grease
Silt Depth: **0** (in.) Deposits Extent:
Infiltration: **None** Pipe Seal Cond: **Sound**
